The Structural Insulated Panel “SIP Hut”

Preliminary Evaluation of Energy Efficiency and Indoor Air Quality

Final Report

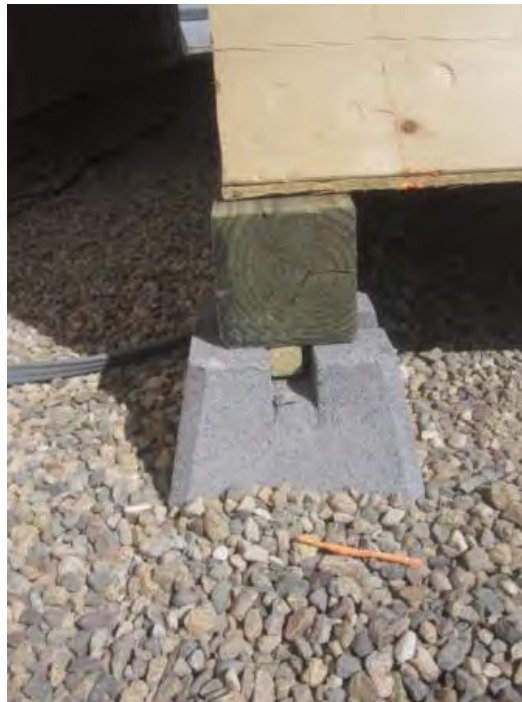
Figure 2-2. Site conditions at Camp Roberts.

The Camp Roberts site was a very level site with an existing crushed stone foundation (Figure 2-2). Minimal changes in gravel elevation were required to construct a level building foundation. The delivery truck parked adjacent to the construction site and a forklift was used to stage the SIP bundles for ease of construction.

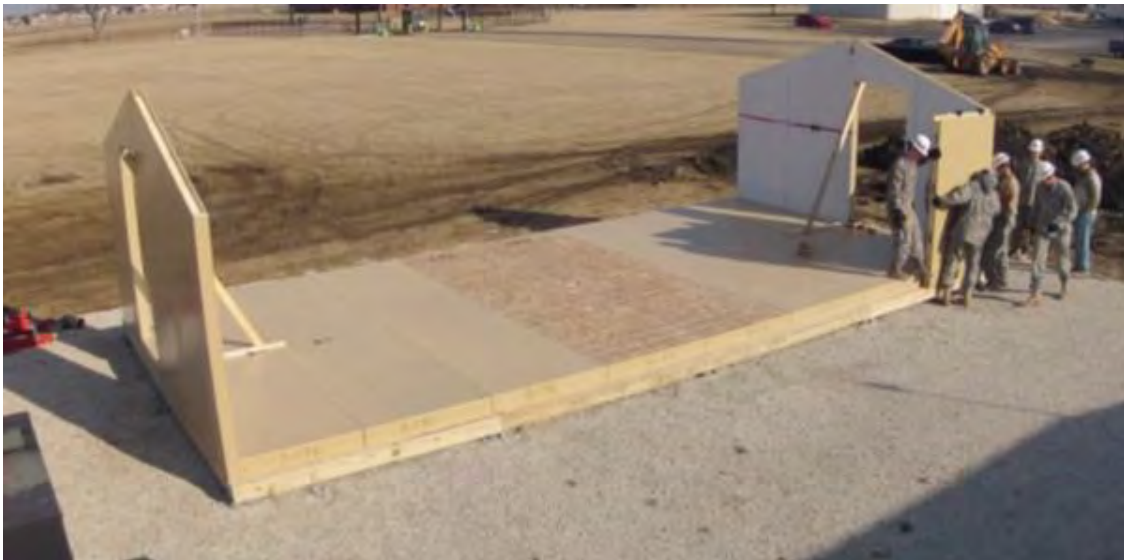
Figure 3-9. SIP hut wall construction.

This version of the SIP hut implemented a few upgrades. One of these was smaller dimensions. The wall heights were shortened to 6.5 ft. They were also shifted to sit directly on the foundation beam as opposed to the floor panels. This change allowed for quicker installation because screws were placed through the wall panels directly into the floor panels. The total time spent setting the floor panels was 4.5 work-hours and the wall panels took 9 work-hours. Figures 3-8, 3-9, and 3-10 show the wall panels being set. (Note that two of the floor panels had the LINE-X coating applied to the wrong side, which explains why bare OSB is visible on the floor in Figure 3-9.)

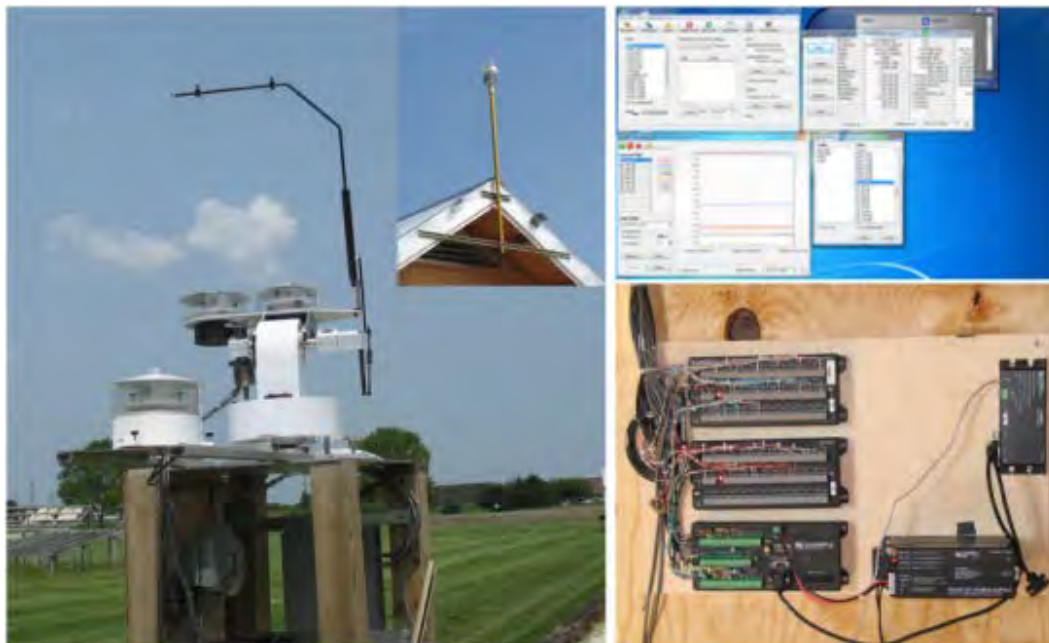
Figure 4-2. Weather station and data acquisition system with remote access capability.

An onsite station is collecting all weather parameters required to create an EnergyPlus weather file to run simulations and to validate models. Table 4-1 lists the performance monitoring instruments and Table 4-2 lists the weather station instruments. An instrument to measure the direct beam solar radiation is mounted on Eppley's automatic SMT solar tracker. A Shade Disk Kit (SDK) is mounted on the SMT tracker to measure diffuse solar radiation using a Black & White pyranometer. Each sensor reading is recorded at 5-minute intervals using a Campbell Scientific micrologger CR3000 (Campbell Scientific 2015) along with multiplexers. Two data files were maintained; one with 5-minute interval data and a second one with hourly data. Remote access of data for periodic monitoring and archival is performed through a telephone modem. Each heat flux transducer (HFT) was calibrated at ORNL using a LaserComp Fox-605 heat flux meter (LaserComp 2015). Figure 4-2 shows the data acquisition system (DAQ) and weather station.

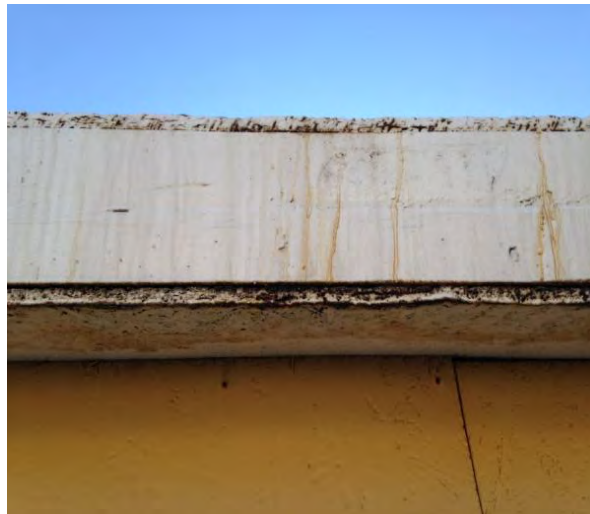
Figure 6-7. Deterioration of the edges of the SIP OSB panels on roof eave fascia.

Figure 6-7 shows deterioration of the edges of the SIP's OSB panels on the fascia of the roof eave. Some separation of the exterior coating is also visible on the bottom side of the SIP's OSB panel. A temporary solution is to apply wide high-performance sealing tape (Figure 6-8) over the fascia surface to cover the edge seams of the SIPs to prevent water intrusion. This type of tape, while very durable and UV-resistant, cannot be exposed to the atmosphere indefinitely and should be covered by flashing when the metal roof is installed. Performing these added steps of roof protection will of course increase the SIP hut construction time, and require additional carpentry skills.
